Abrams Tank Systems

Lessons Learned
Operation Iraqi Freedom
2003

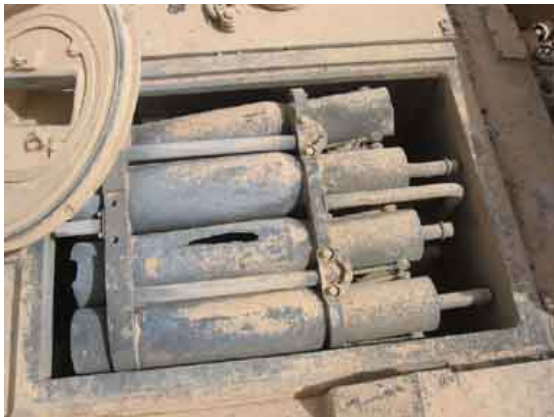
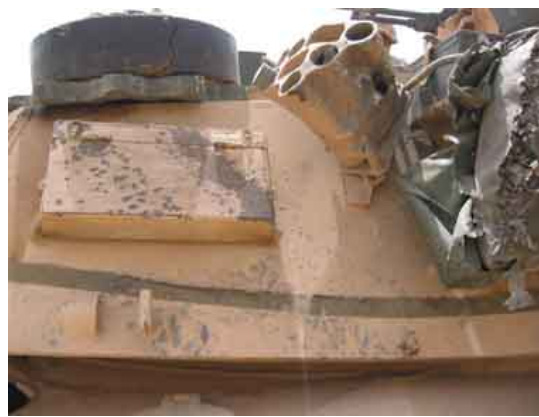
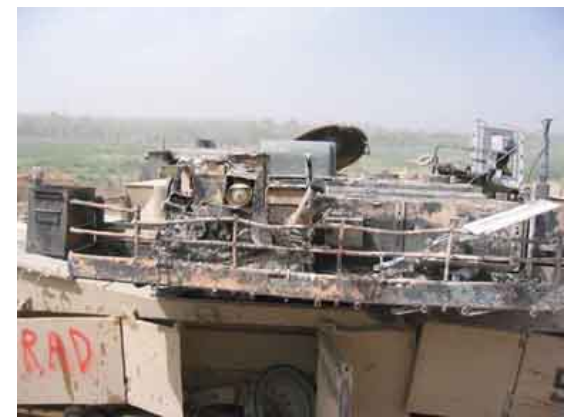
- | **Turret ammunition blast doors worked as designed**
 - ❖ Documented instance where turret ready rack compartment hit and main gun rounds ignited. Blast doors contained the explosion and crew survived unharmed except for fume inhalation
- | **Externally stored items highly vulnerable to small arms fire**
 - ❖ In some instances, catastrophic losses resulted from burning EAPU material and/or packaged POL products dripping down into the engine compartment catching the engine on fire
 - ❖ Many instances where TA-50 lost or damaged due to enemy fire or secondary affect
 - ❖ Lesson Learned – Review and adhere to established load plans

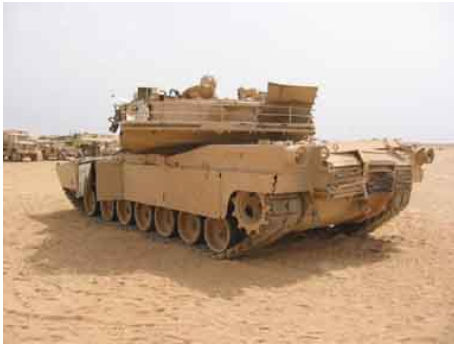
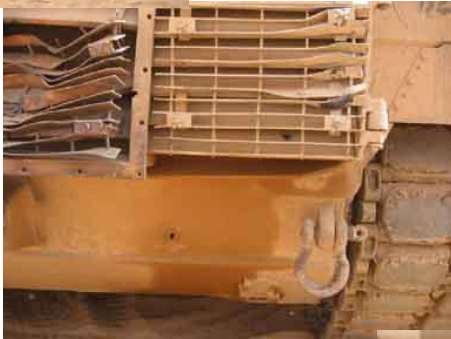
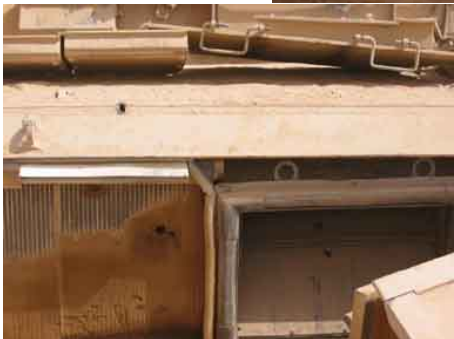
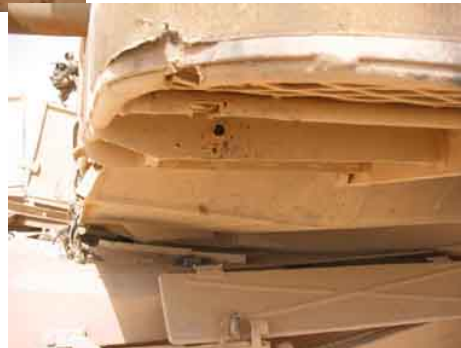
2 April, Karbala – Anti armor RPG attack

Pitting from multiple
small arms

RPG

Glanced off top of turret

1-1 1/2" penetration

25mm

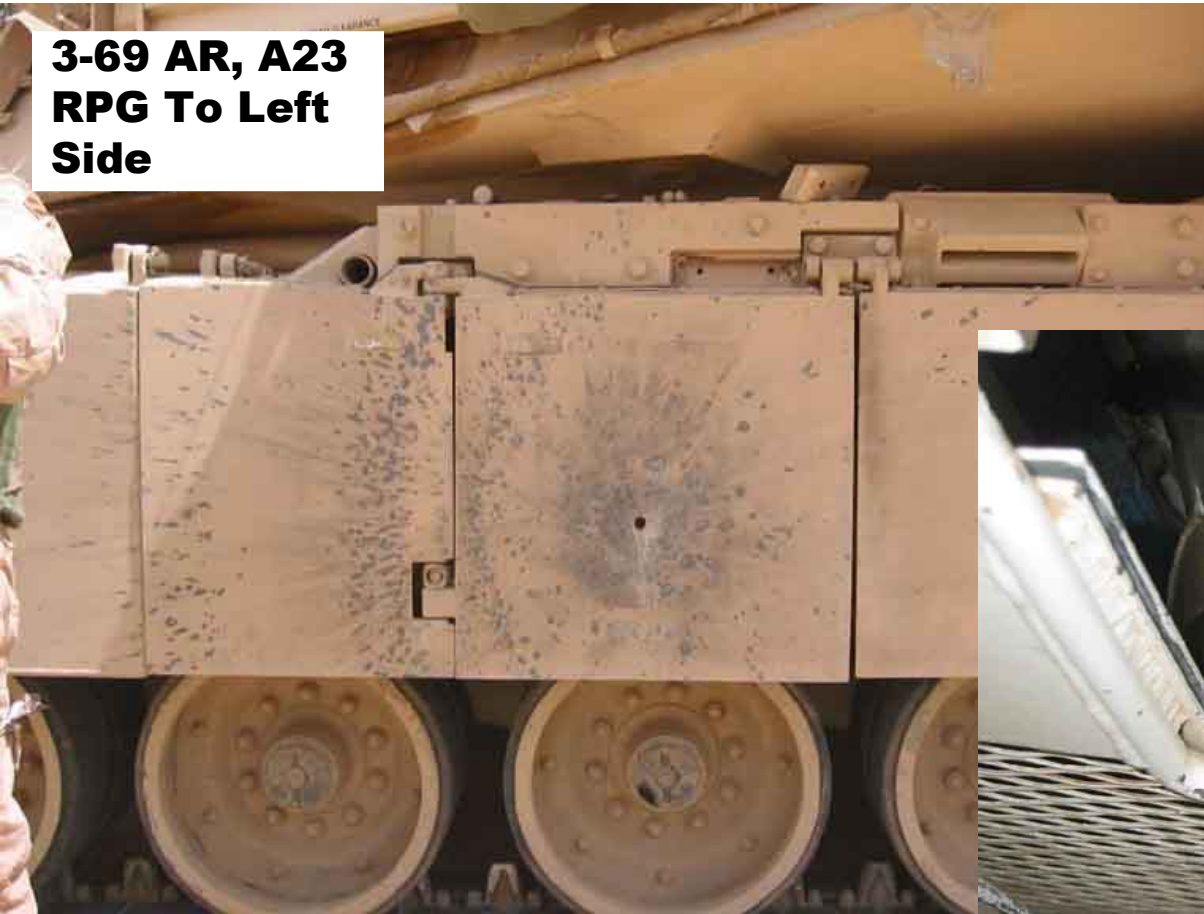
**3-69 AR, A23
RPG To Left
Side**

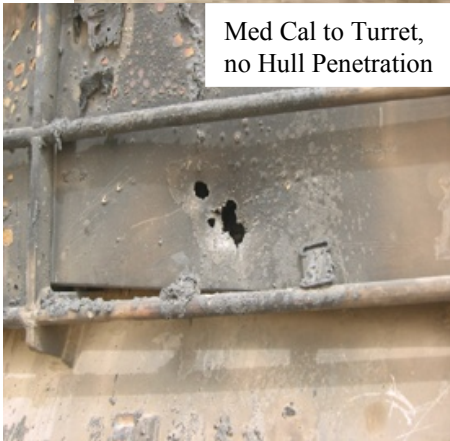
Med Cal to Turret,
no Hull Penetration

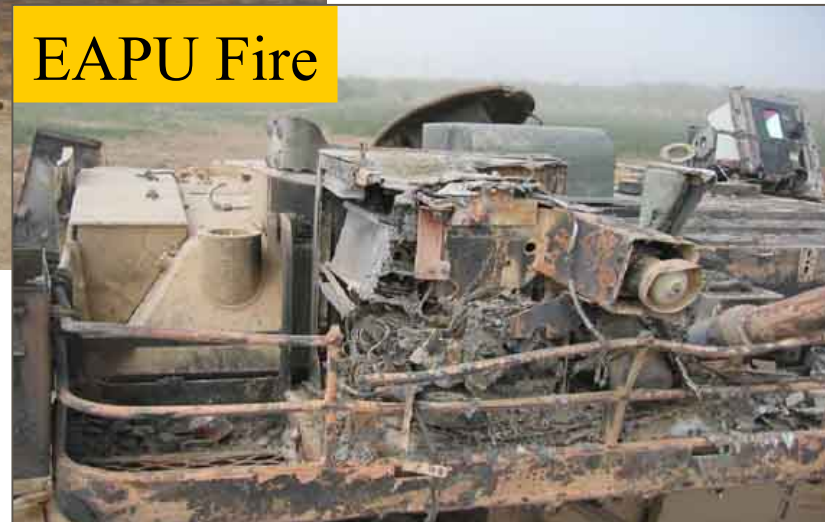
EAPU Fire

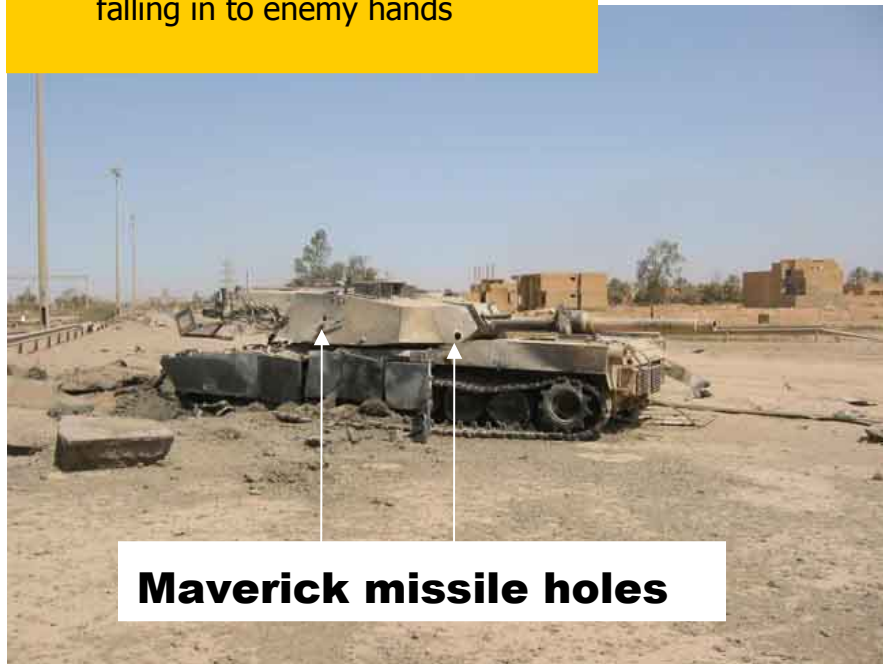
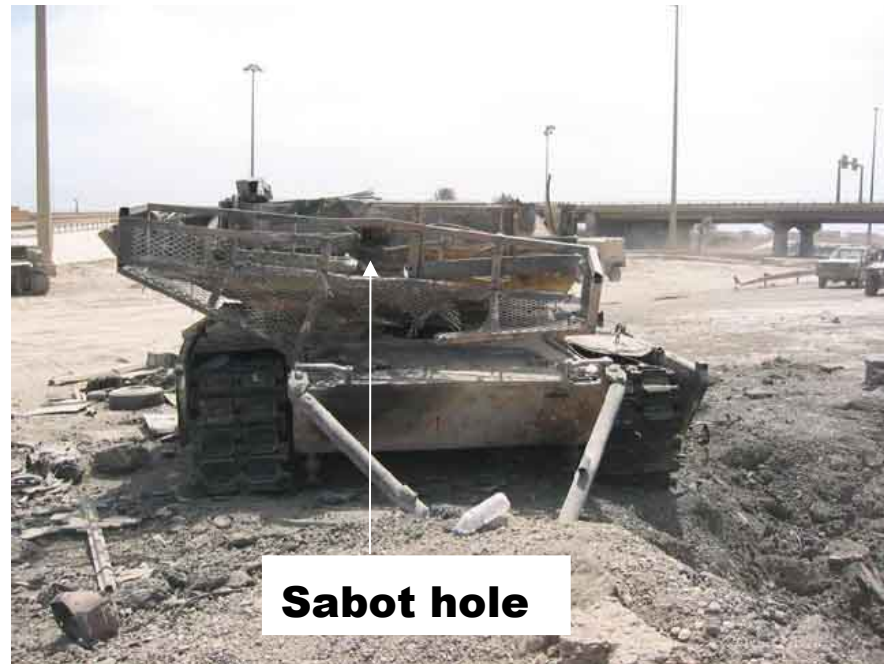
1-64 AR, C12

Being towed back to UMCP
because of engine fire. Purposely
destroyed by unit to keep from
falling in to enemy hands

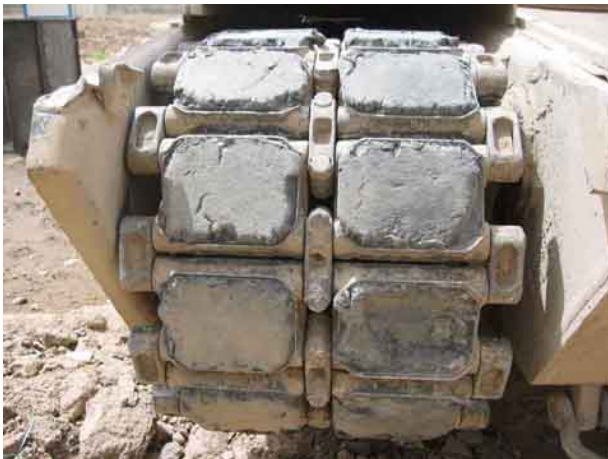
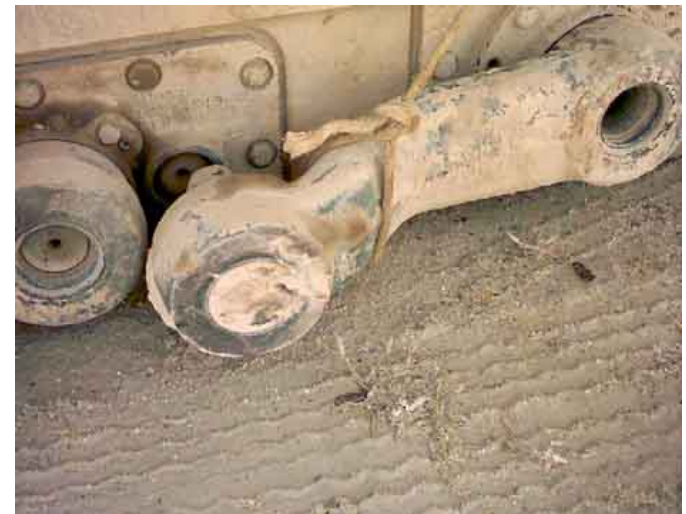
- | **APS fleet is not equipped with PJAS. Given the extreme dusty conditions, VPACs required continuous cleaning and servicing by crews. Suspect lack of PJAS contributed to higher rate of engine failure**
- | **Suspension Issues**
 - ❖ **High rate of failure on #2, #3 and #5 left and right road arms and assemblies**
 - **Under investigation by PM Abrams and GDLS engineers**
 - ❖ **Road wheels and track wear proved to be significant over long distances and high rates of speed**
